Replacing insert and liner

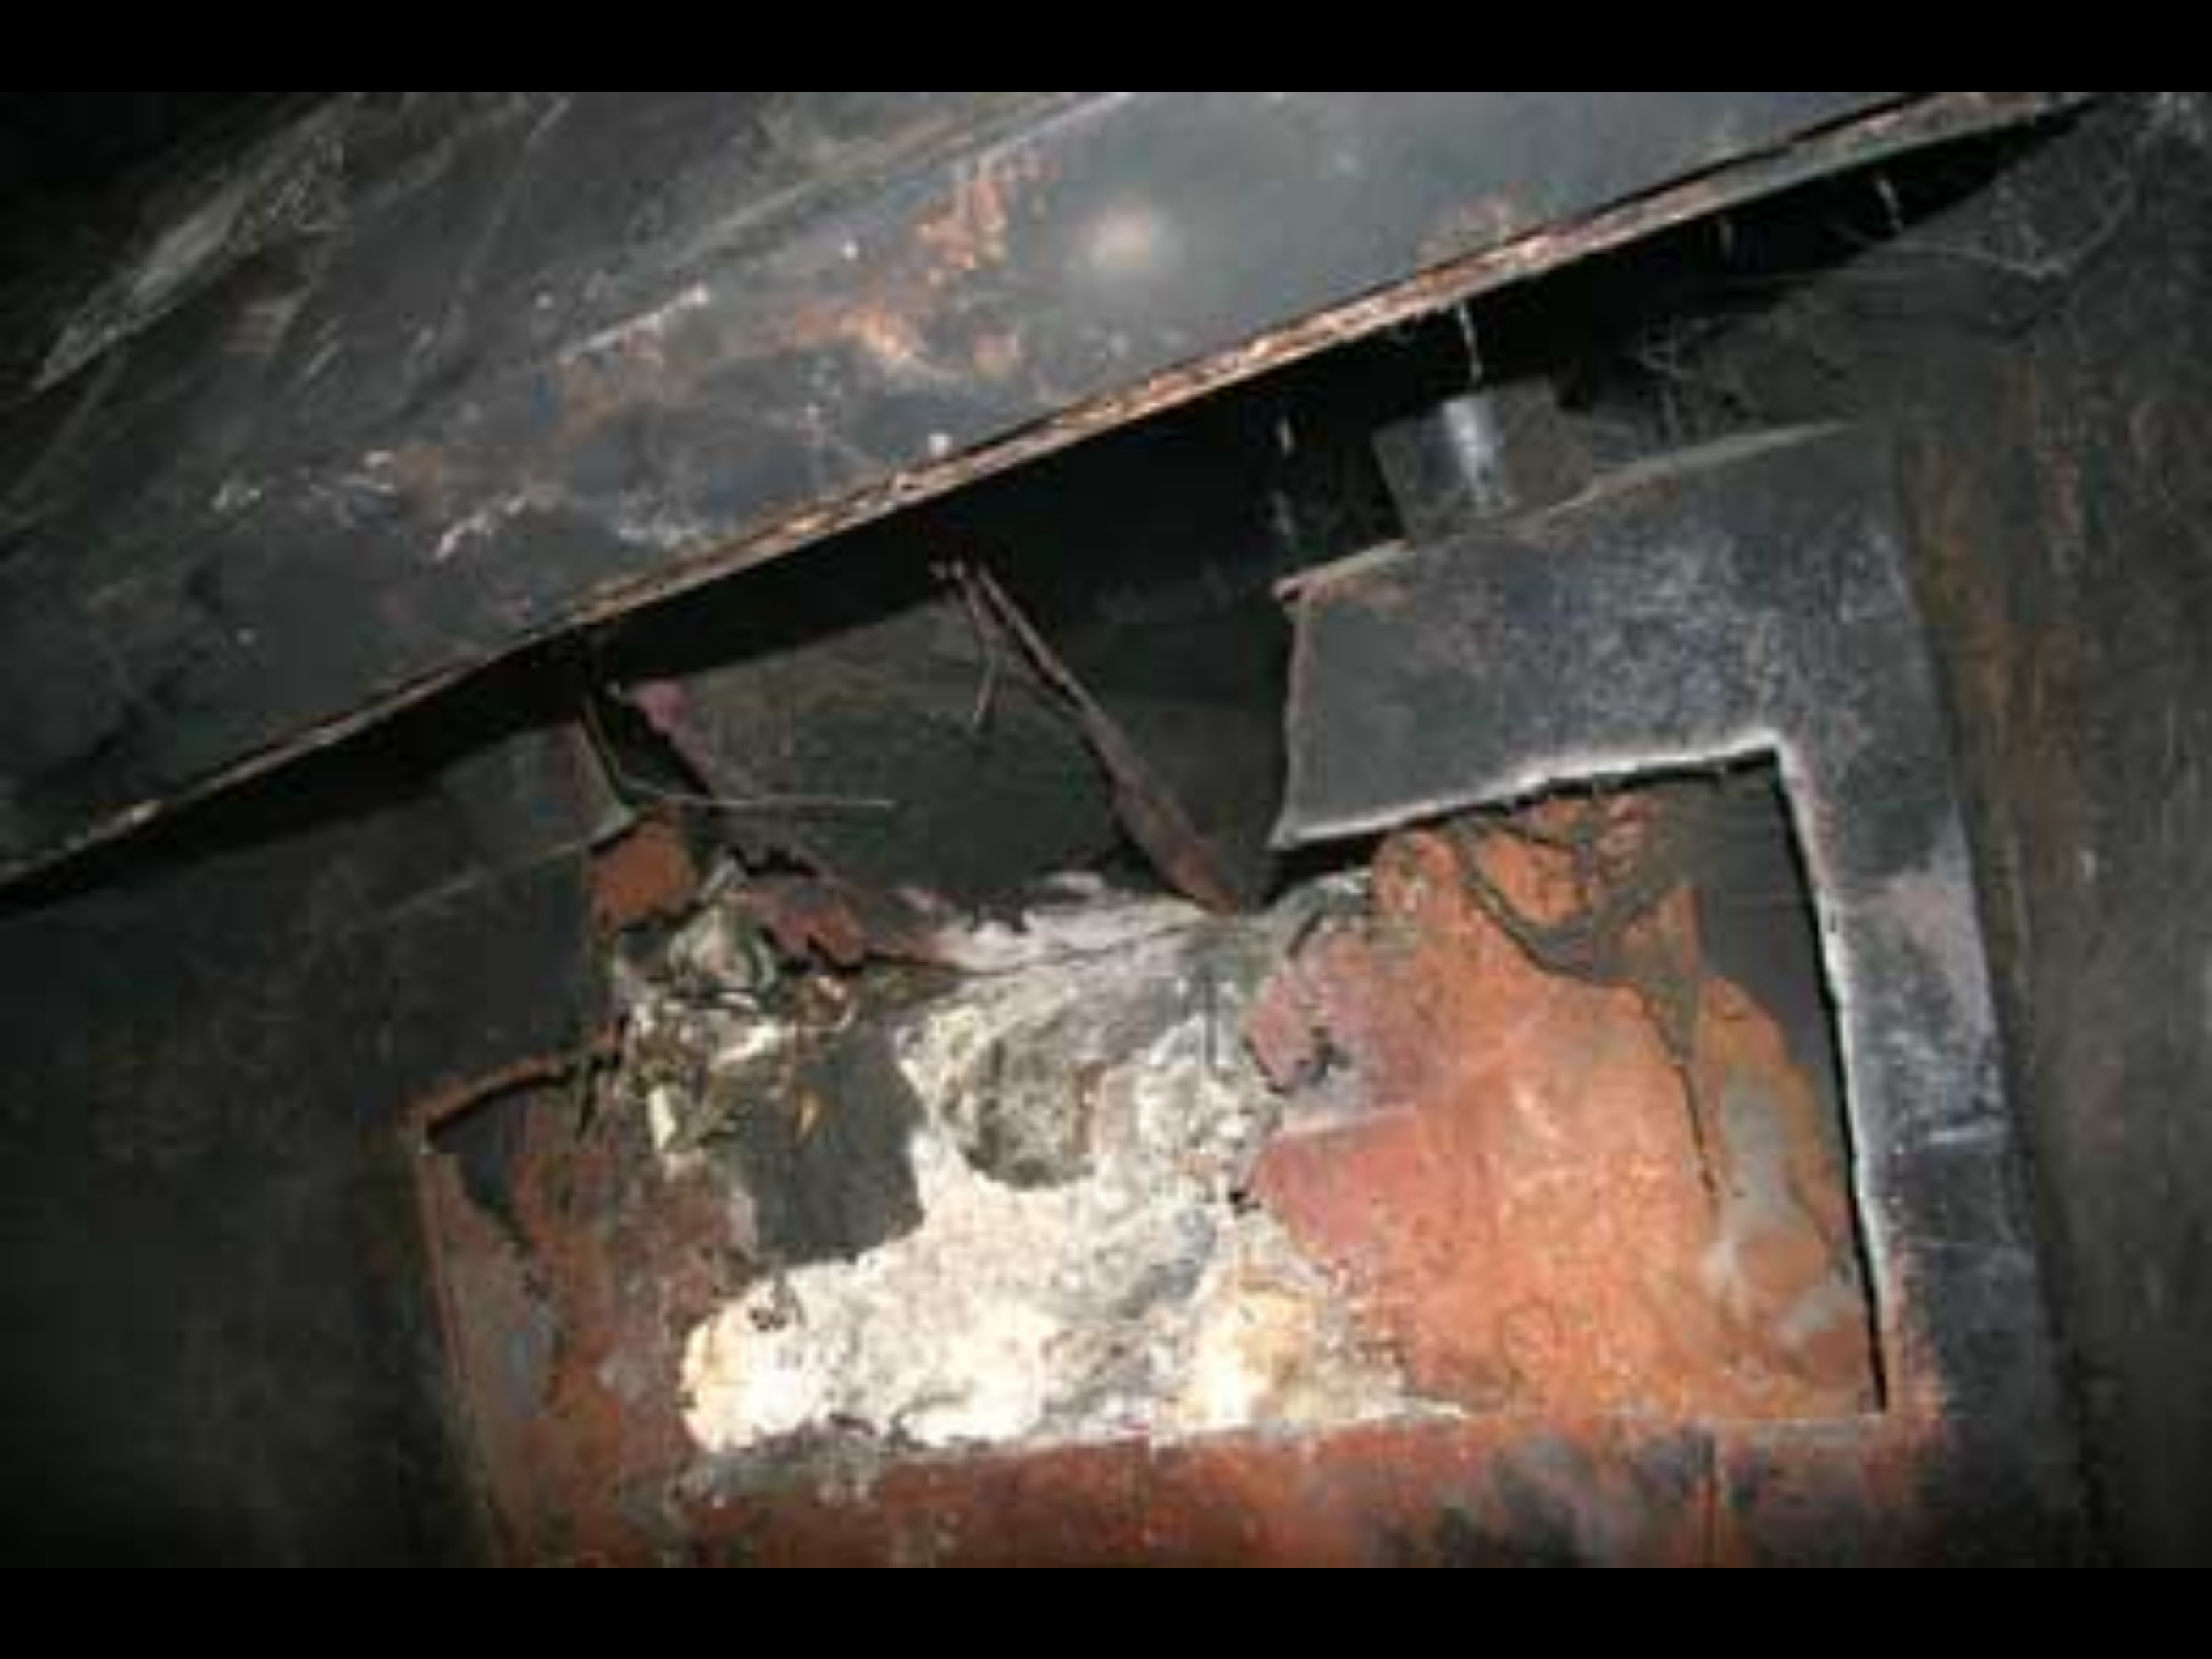
What was left of the rusted out pipe

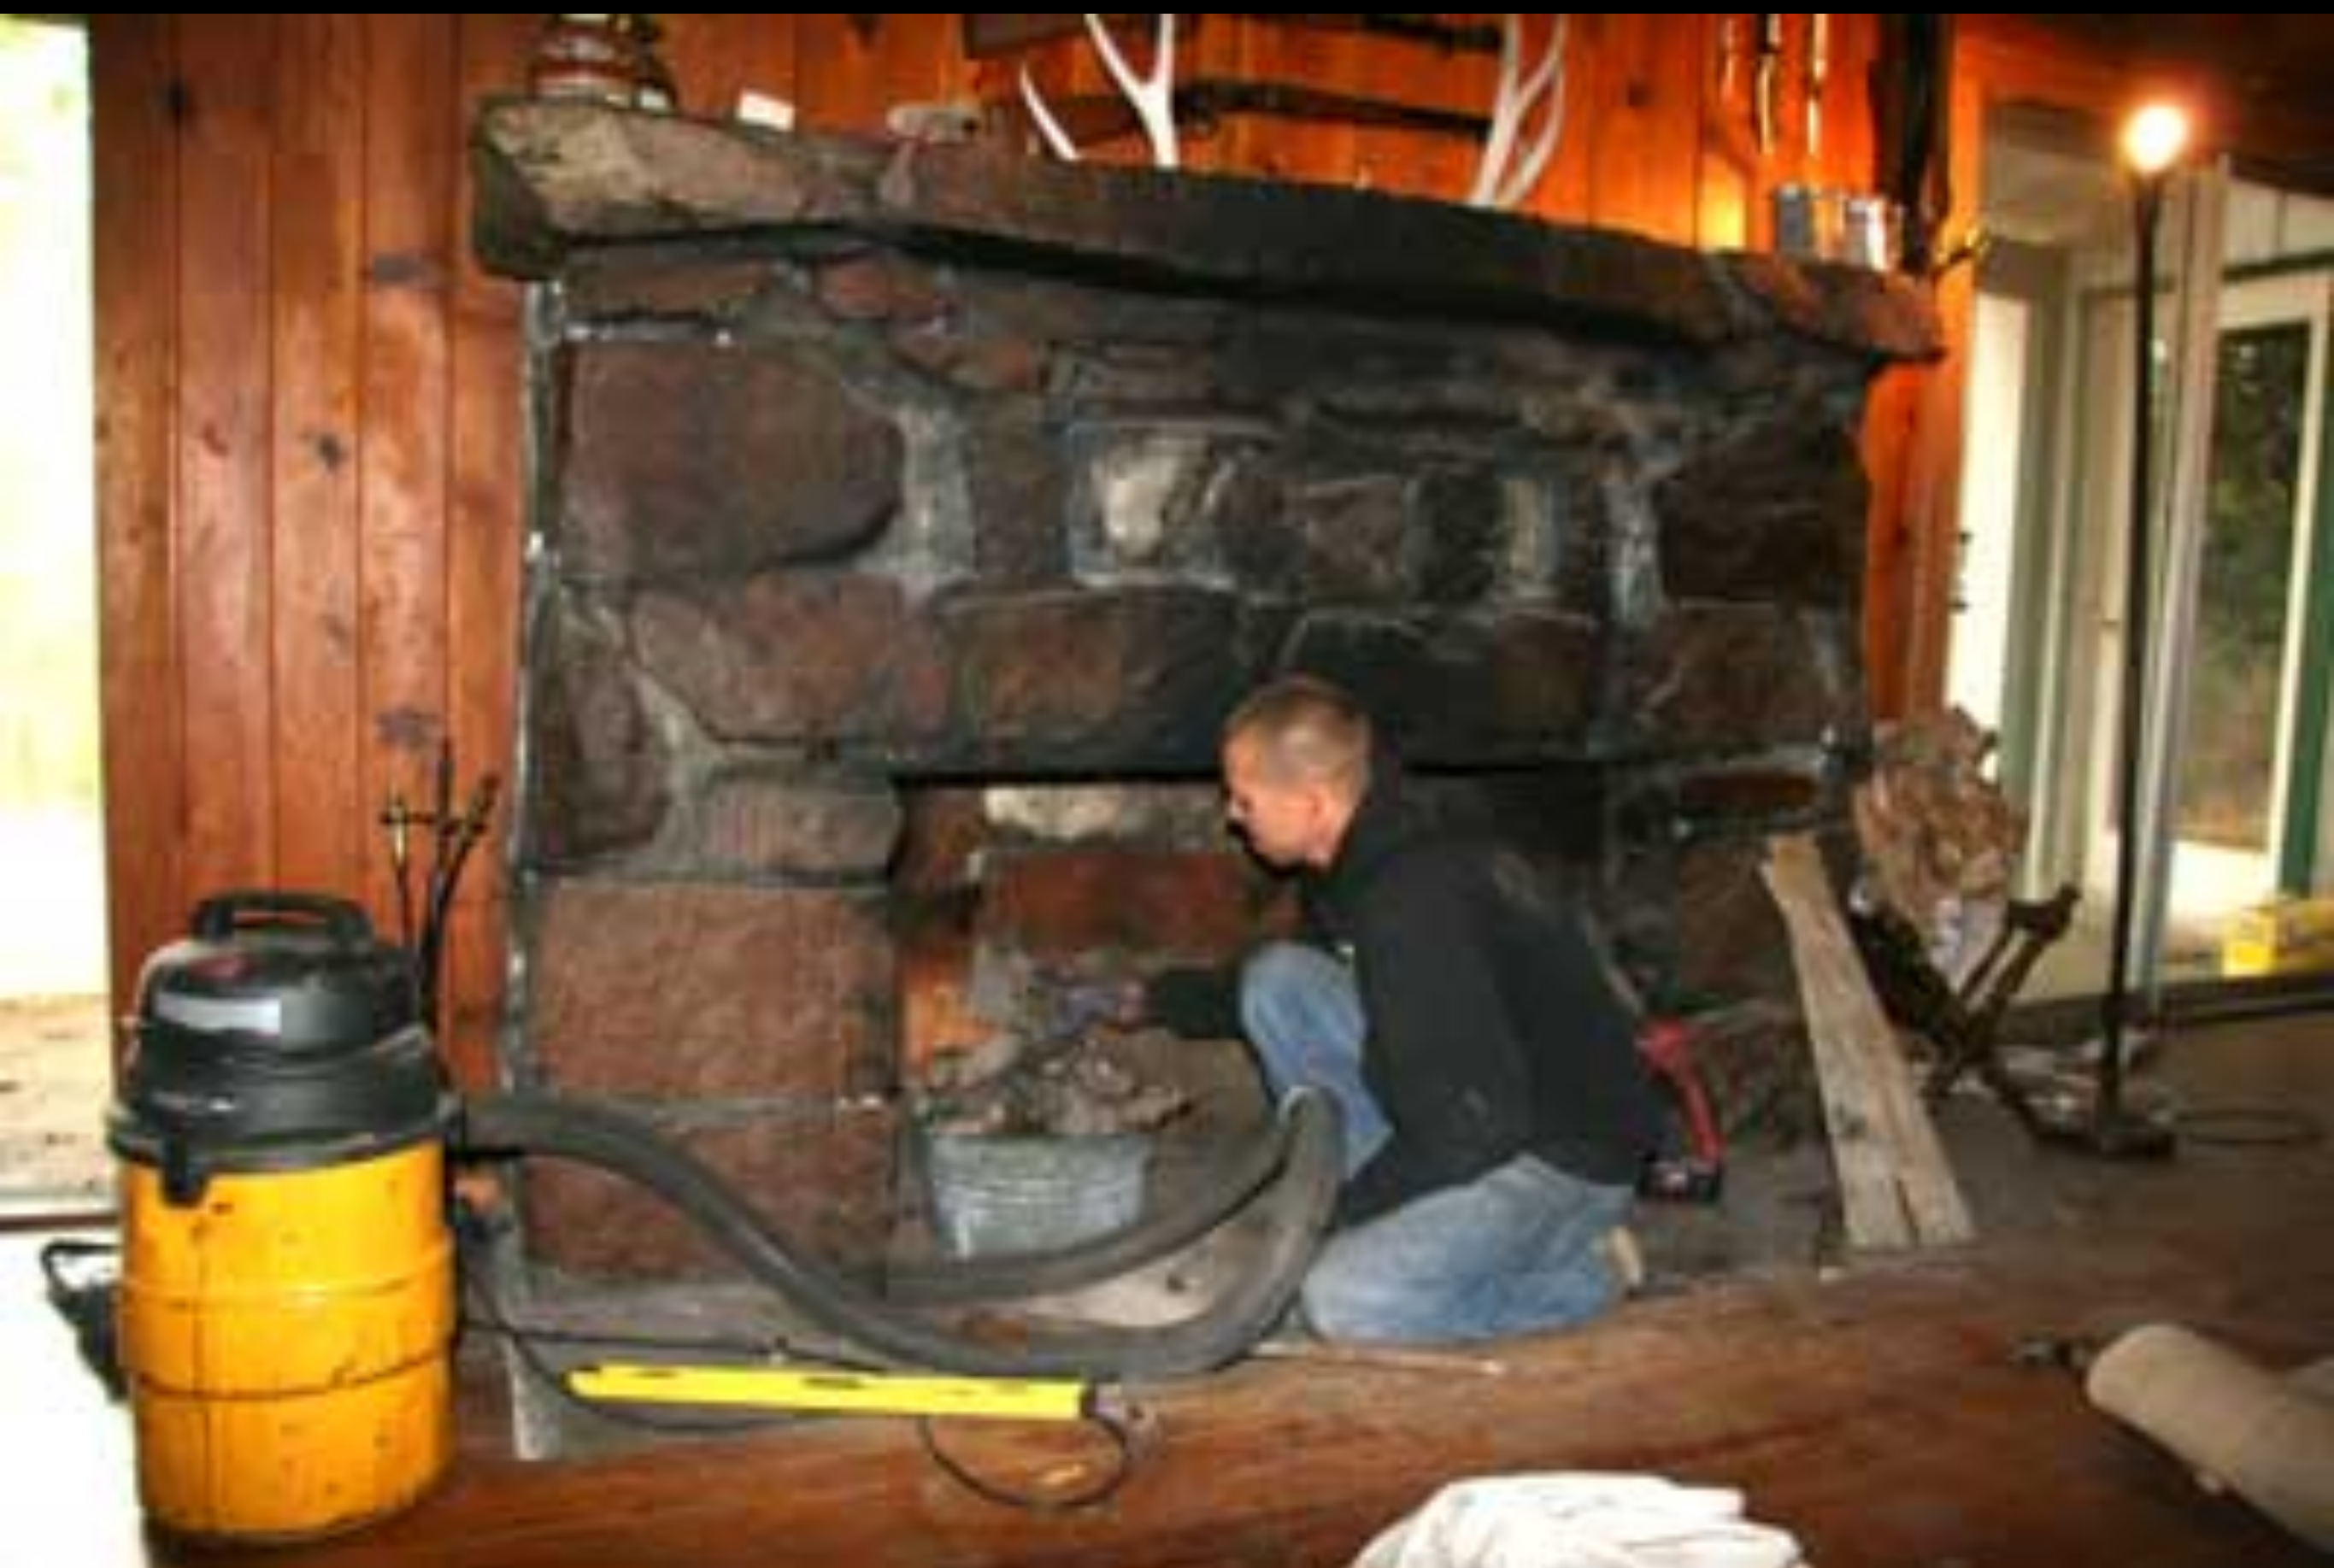
Someone did a real Hack job
on the heatalor

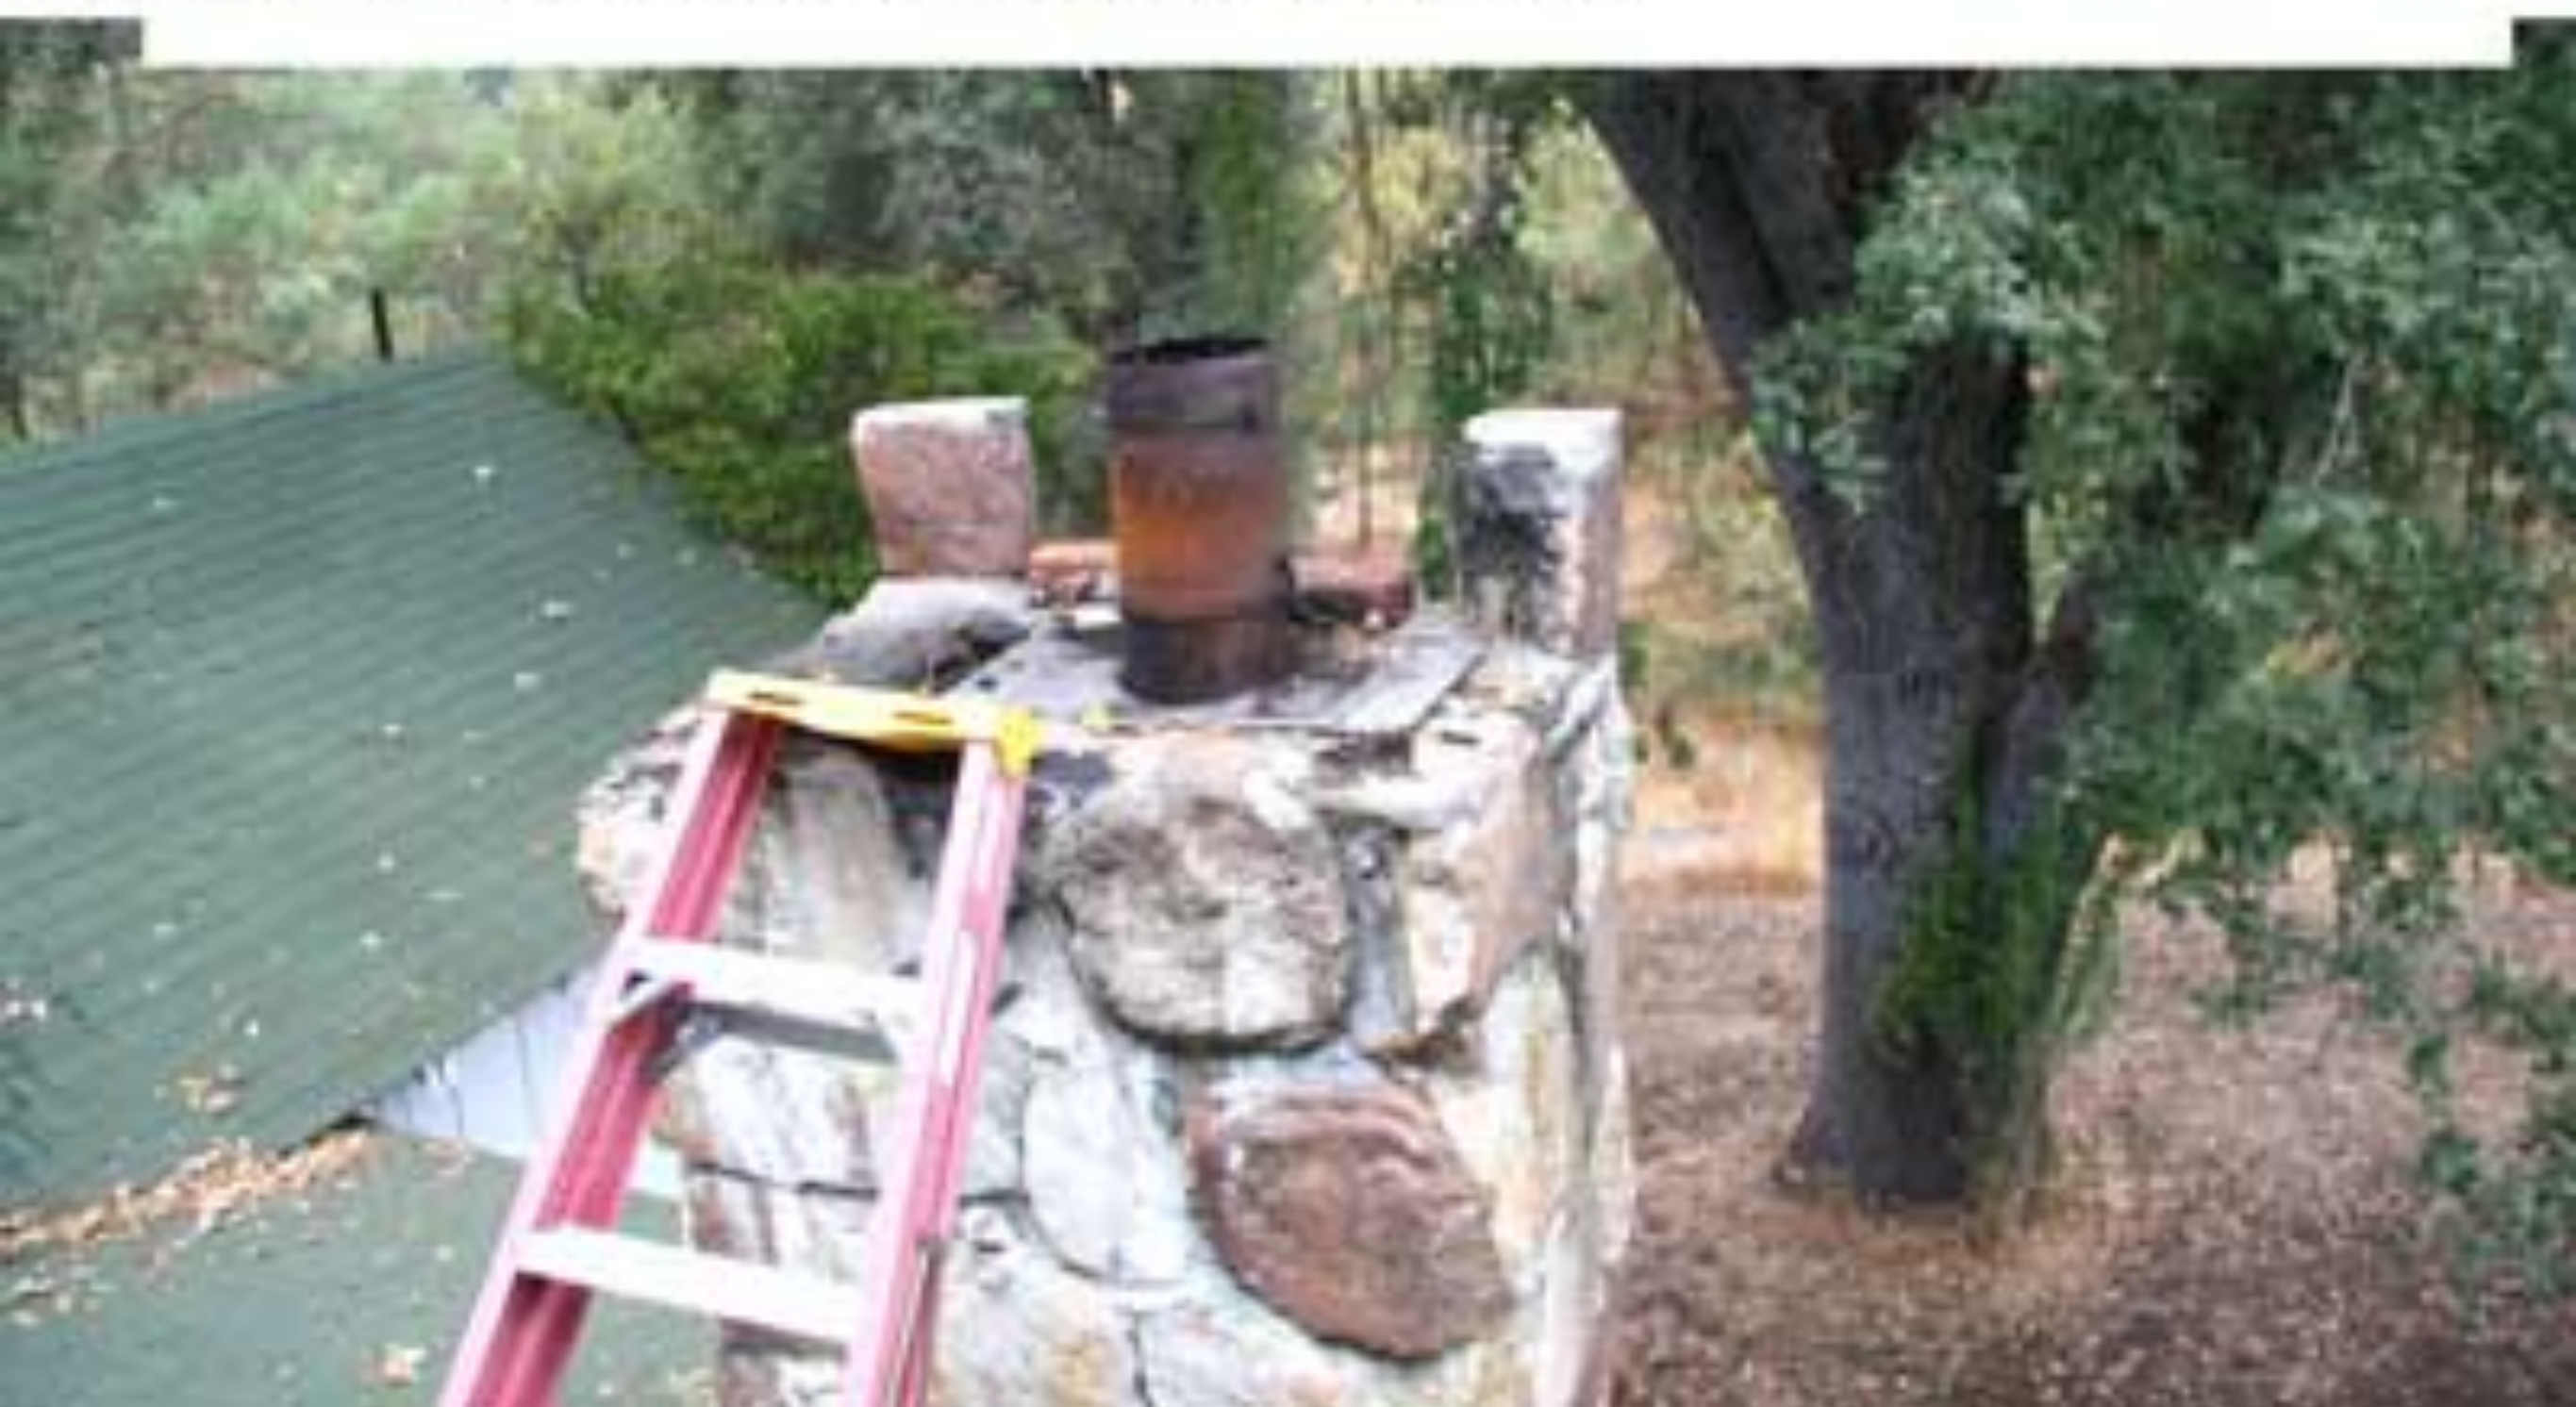
Black steel pipe was used and no weatherproof chase chap.
Water ran down the Masonry chimney

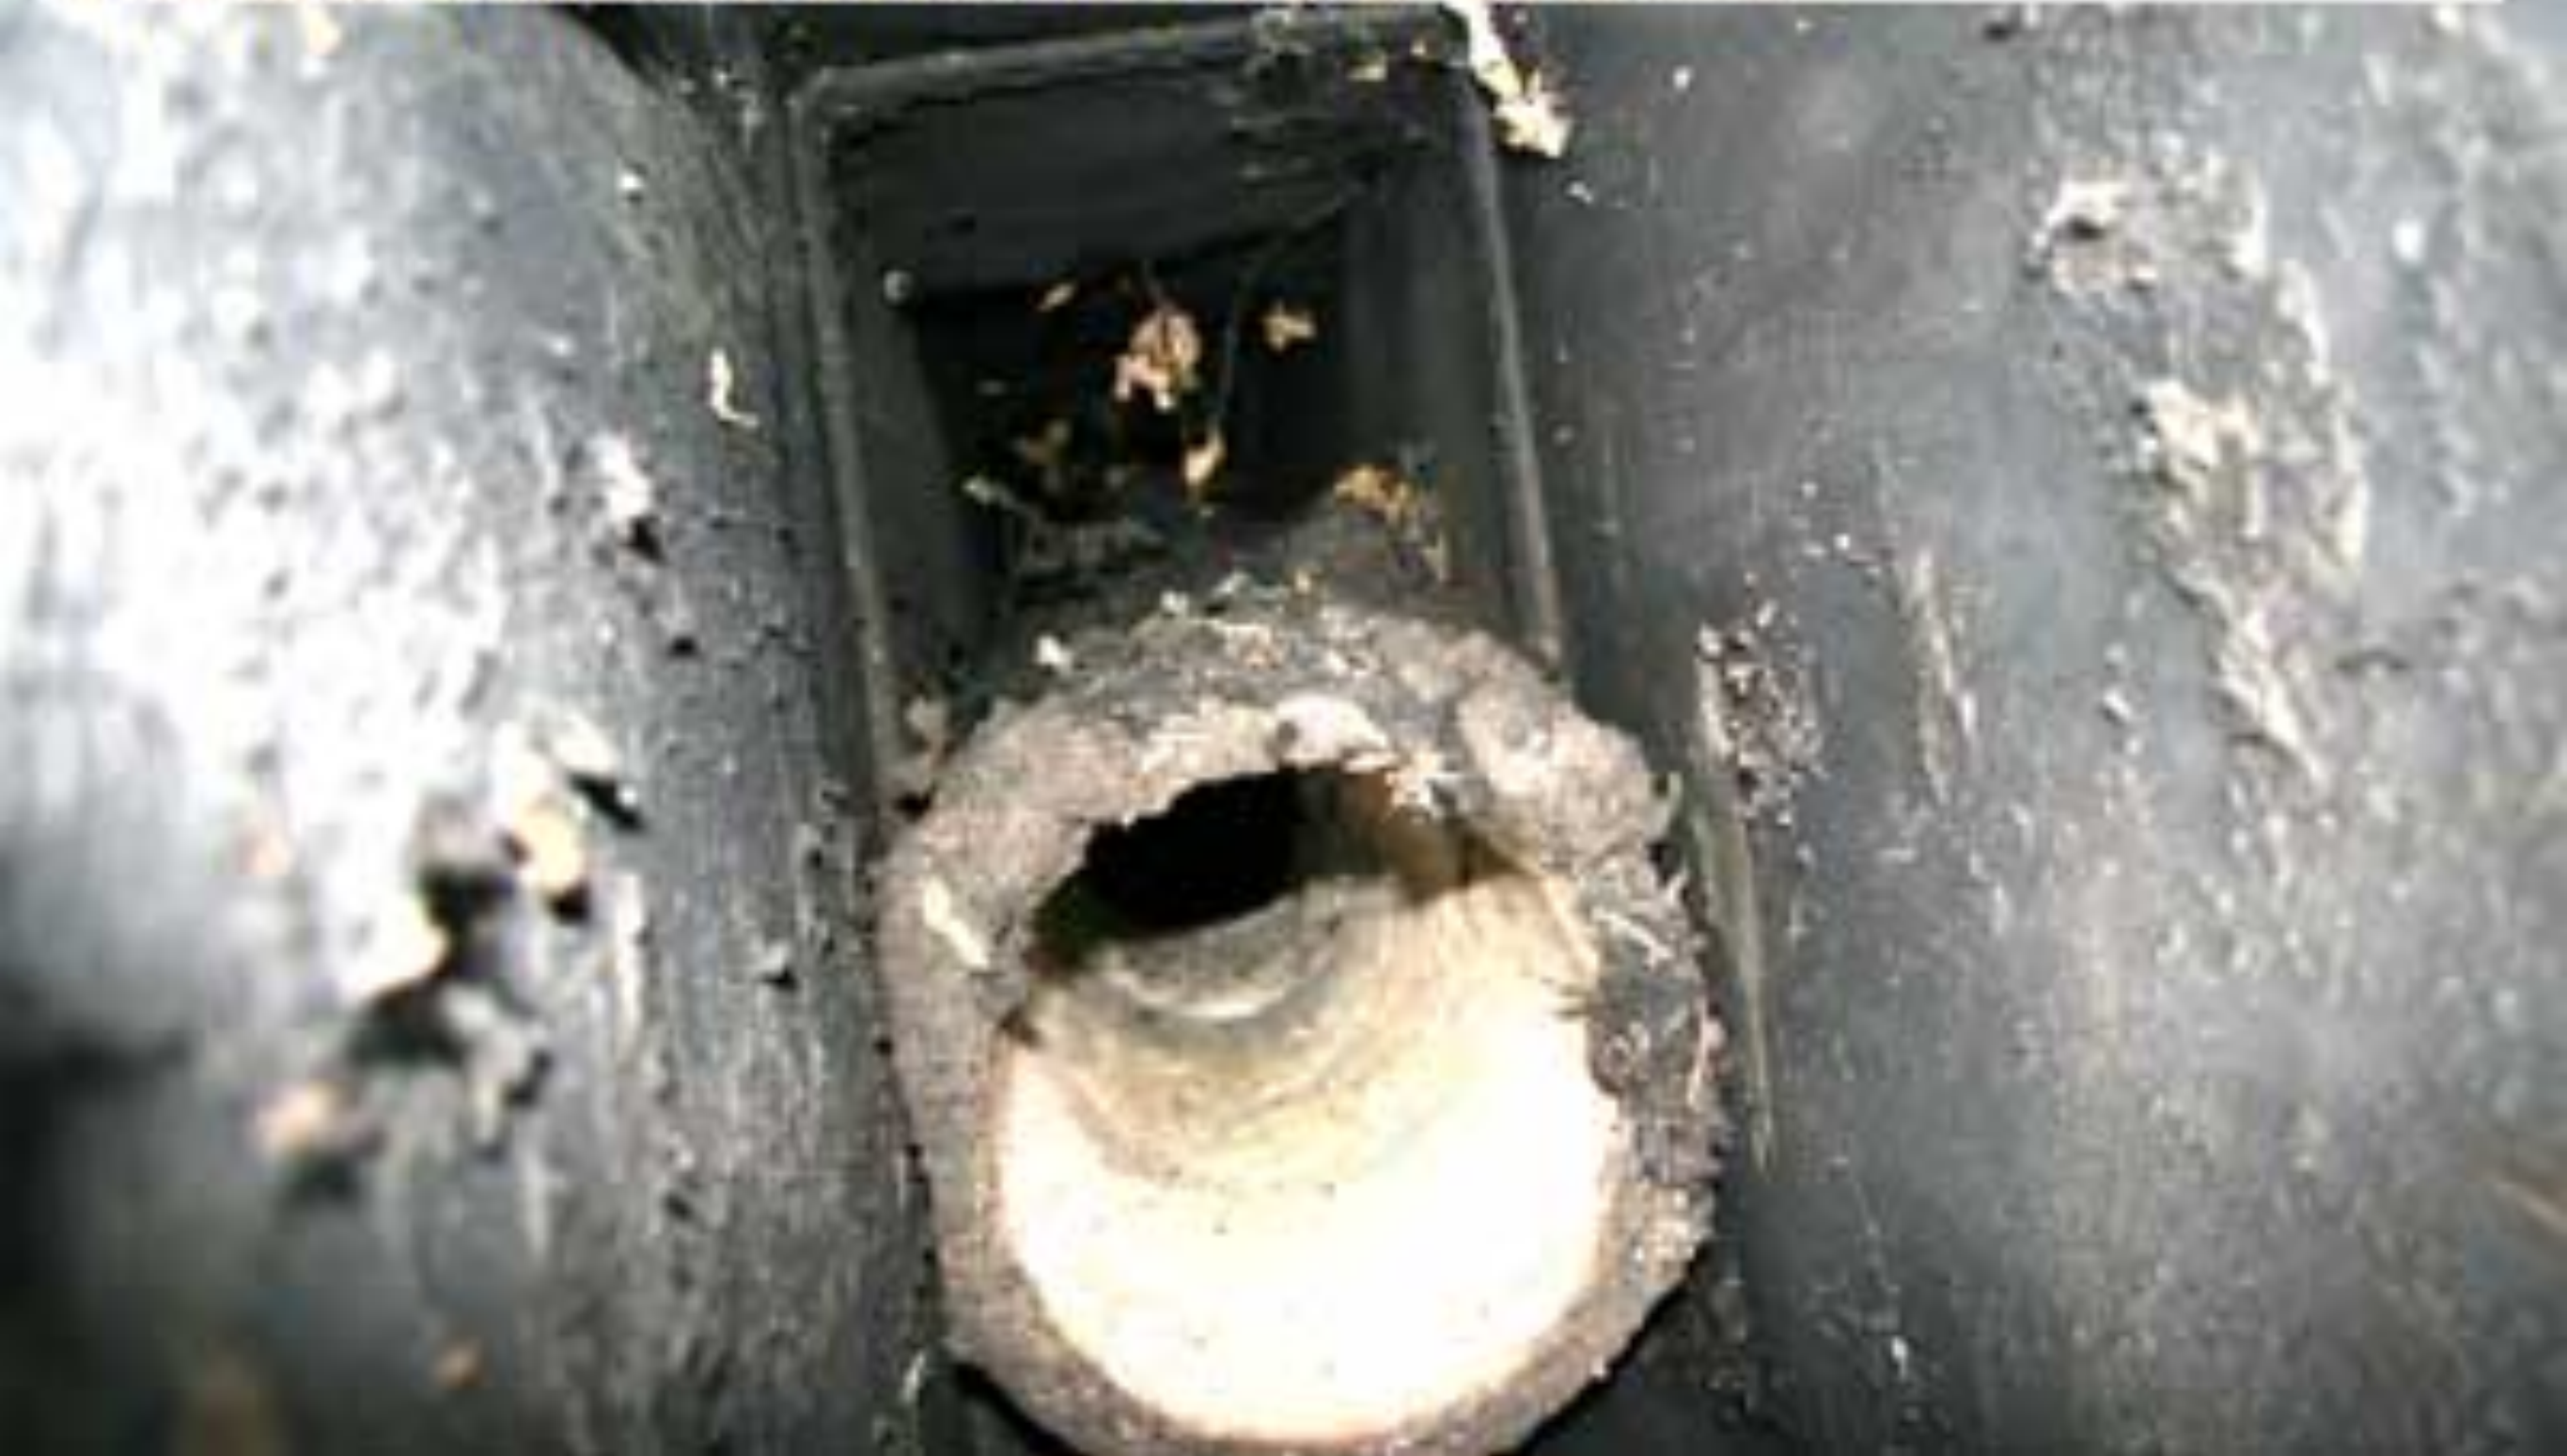
Only part left of the Old Black Steel liner was the liner blanket
The rest crumbled down into the smoke self.
